**HAMMAM AL ALIL DIVISION TRAINING
CENTER
MOSUL, IRAQ**

**SIGIR PA-09-174
JANUARY 7, 2010**

Summary of Report: PA-09-174

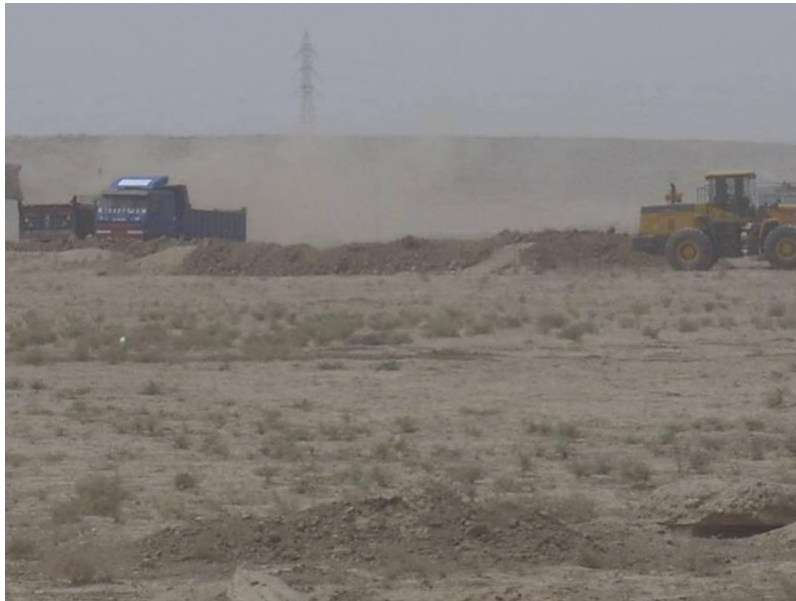
Site Photo 1. Site location prior to construction (Courtesy of USACE)

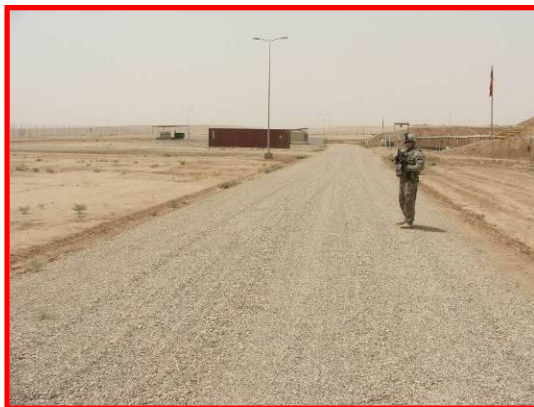
Site Photo 2. Access road

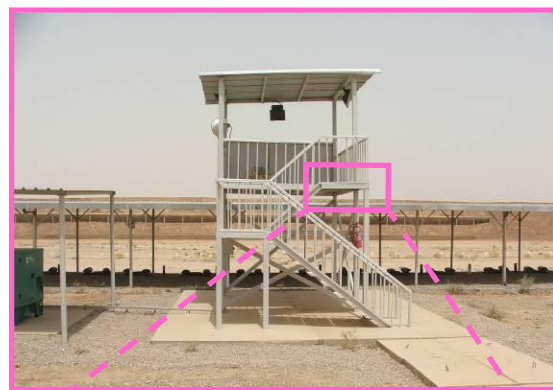
Site Photo 3. Range tower

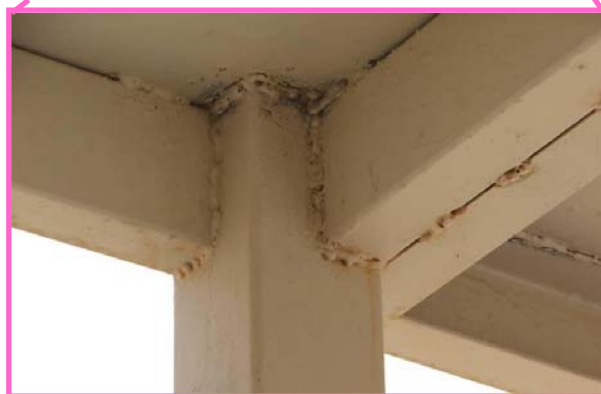
The contractor furnished metal containers for target storage and administrative materials that were located inside the chain link fence. Range towers were constructed directly behind the firing positions and had a roof, staircase, and spotlight. The range towers were constructed with steel framing and metal plate decking which were joined together with what SIGIR observed to be poor quality welding (Site Photo 3). However, the connections used the entire perimeter of the joining members as faying⁵ surfaces, and relatively light loads were expected in the tower, so the connections appeared adequate (Site Photo 4).

Site Photo 4. Poor weld quality at connections

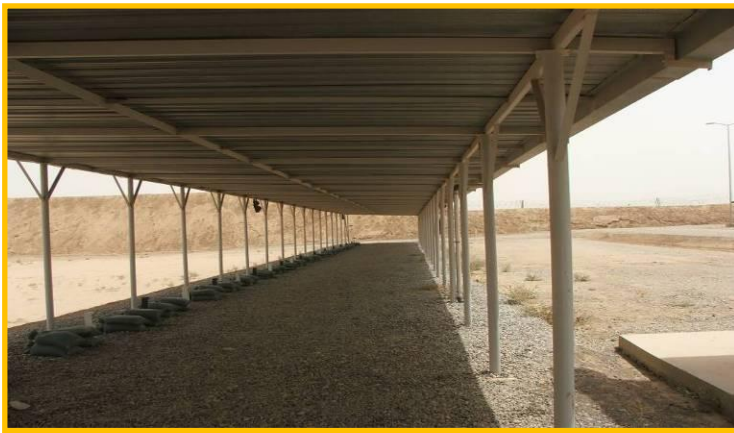
At the up-range end of the small arms range were the outdoor training facility bleachers, and firing positions (Figure 4). The firing positions were constructed with coarse aggregate pads and an overhead sunshade (Site Photo 5). The contractor constructed the sunshades over the firing positions with corrugated metal roofing supported on steel framing.

Site Photo 5. Firing positions

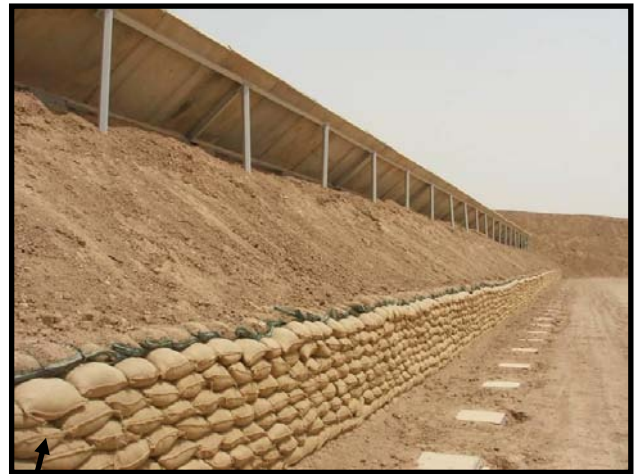
The GRN Mosul Area Office representative stated that the original construction for the ricochet catcher included light gage steel angles supporting the concrete panels. After initial construction, the angles failed under the weight of the panels, and the contractor was required to replace the angles with steel I-beam sections.

Site Photo 6. Ricochet catcher

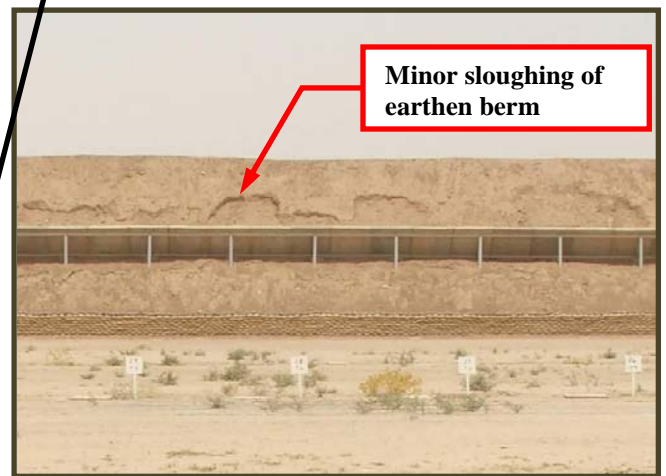
Site Photo 7. Earthen berm

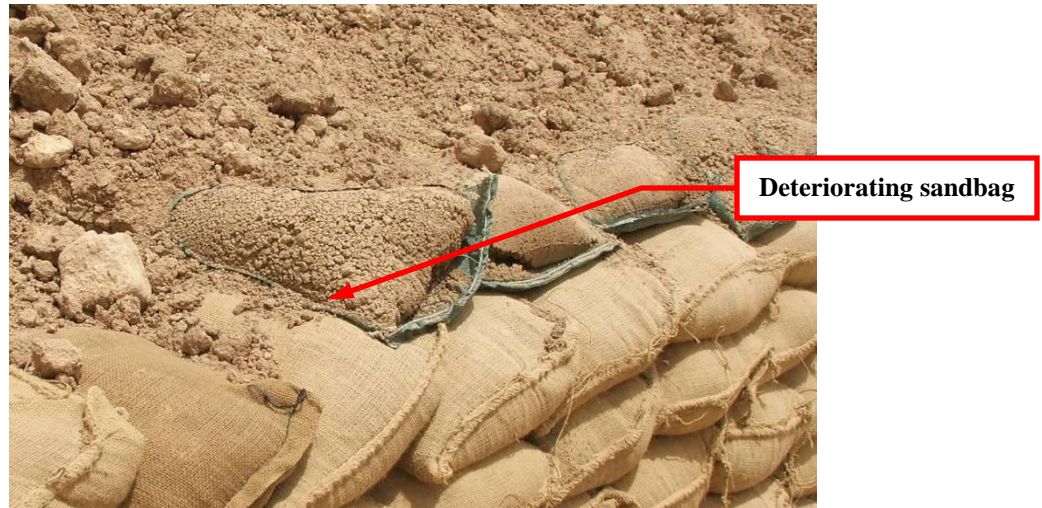
The contractor was required to provide 1,500 sandbags, filled with sand, for the project. During the site assessment, SIGIR observed that the contractor used two different types of sandbags. The contractor used one type of sandbag that was natural fiber and a second type of sandbag that was constructed from polypropylene (type of plastic). Polypropylene sandbags are known to degrade in sunlight; therefore, polypropylene sandbags require covering to prevent deterioration. Several of the polypropylene sandbags had already deteriorated (Site Photo 8). In addition, the contractor used the polypropylene sandbags to construct a headwall for the drainage pipe through the earthen embankment (Site Photo 9). At the time of the site assessment, a majority of the sandbags used in the construction of the headwall were disintegrating. The failure of the headwall coupled with the instability of the slope material will likely lead to a localized collapse of the berm, which will result in blocking the drainage pipe.

Site Photo 8. Deteriorating sandbags

contractor used one type of sandbag that was natural fiber and a second type of sandbag that was constructed from polypropylene. SIGIR observed that some sandbags have already deteriorated. In addition, the contractor used precast concrete planks in several areas as footbridges over the swale constructed to convey runoff away from the range site. SIGIR observed a safety hazard where the contractor had not removed the rebar lifting lugs from the precast planks.

2. Require the contractor to replace all of the deteriorating sandbags located at the division training center project while the warranty is valid.

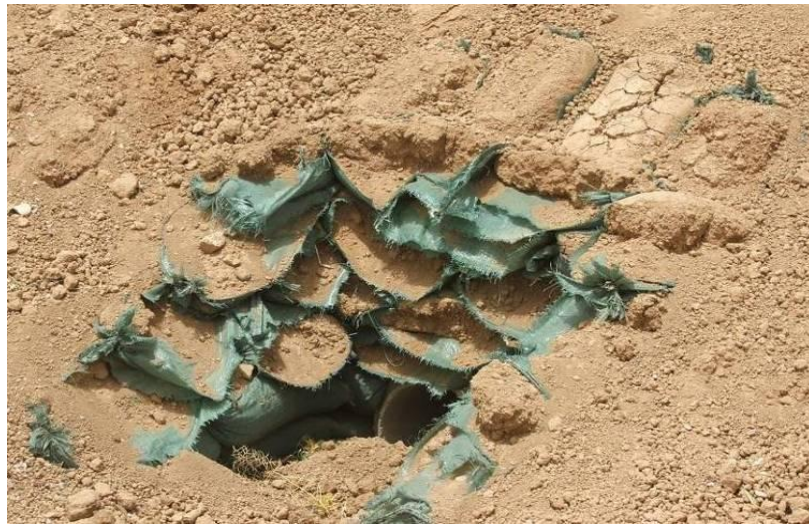
Site Photo 9. Deteriorating headwall

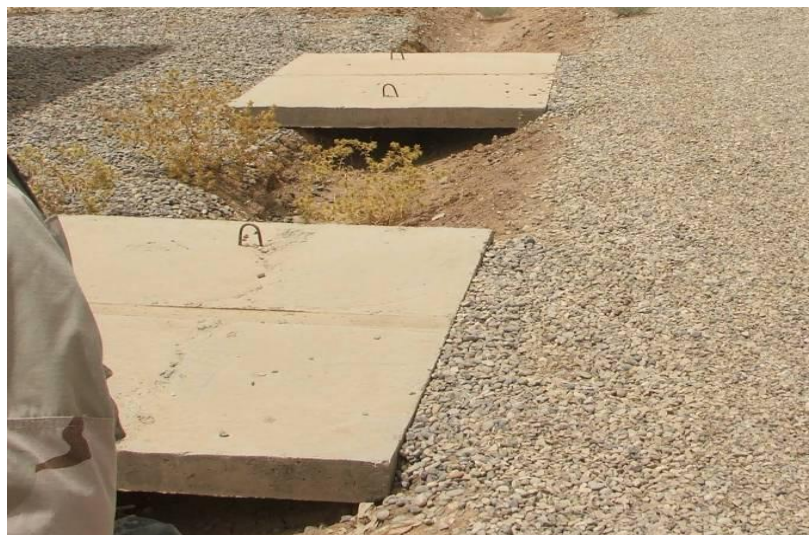
In addition to piping, roadside swales⁹ were constructed to convey runoff away from the range site. The contractor used precast concrete planks in several areas as footbridges over the swale (Site Photo 10). SIGIR observed a safety hazard where the contractor had not removed the rebar lifting lugs from the panels

Site Photo 10. Precast concrete panel footbridge

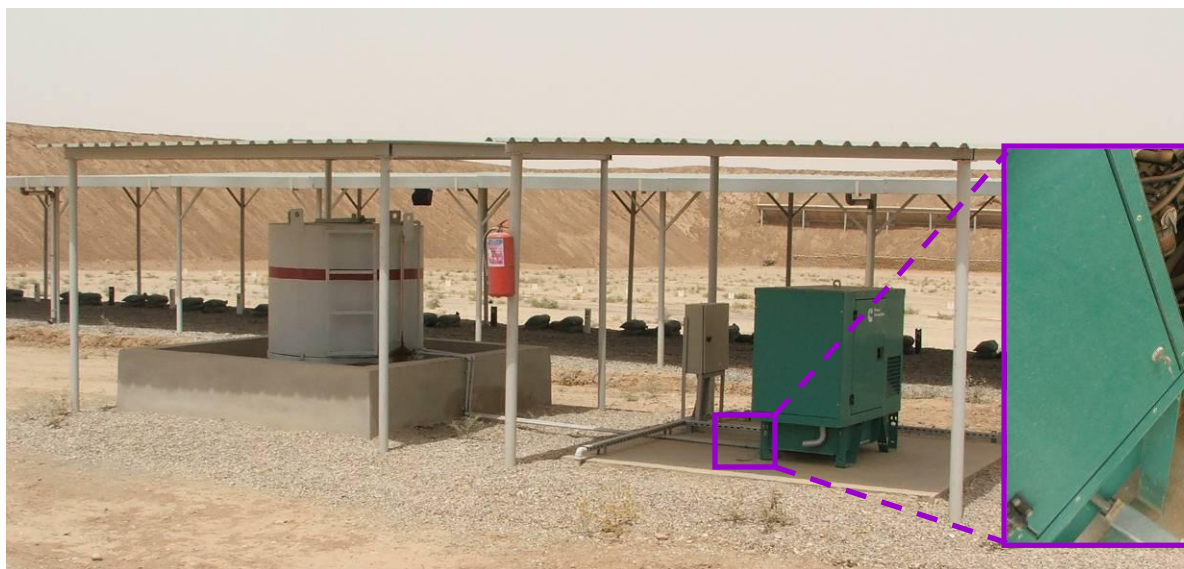
Site Photo 11. Sunshade with generator & fuel tank

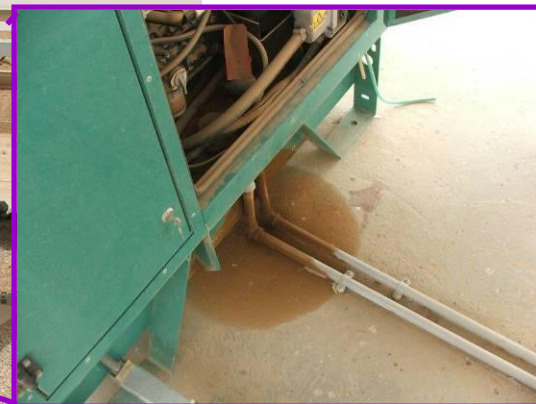
The generator was connected to the fuel tank with galvanized steel piping. SIGIR noted that there was evidence of a fuel leak at one of the joints in the fuel line (Site Photo 12). The GRN Mosul Area Office representative stated that the leak was previously discovered and repaired and that the fuel noted during the site assessment was from an earlier leak. As the Gulf Region District of USACE stated in response to a draft of this report: “Given the frequent sand and dust storms in Iraq, dirt would have re-accumulated had the pipes and foundation been pressure washed or replaced when the leak was repaired.”

Site Photo 12. Fuel leak at joint

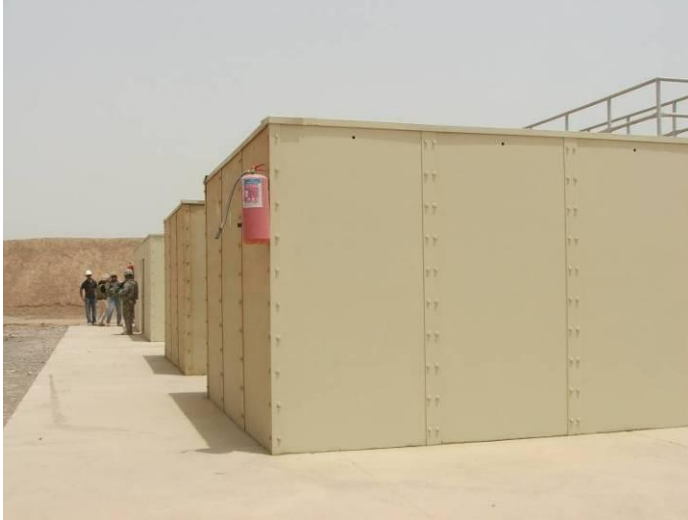
Site Photo 13. MOUT facility exterior

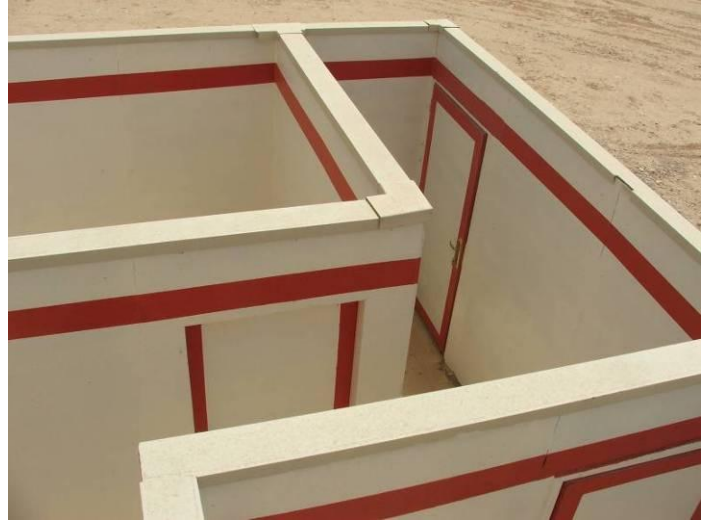
No significant cracking or displacement of the slab was observed, although minor shrinkage and cracking were present, which indicates poor curing practice. However, the minor shrinkage and cracking should not affect the structural integrity of the slab. The training structures utilized modular, panelized construction with bolted connections between the panels. The training structures were constructed without a roof. The panels were arranged to provide rooms and corridors with some panels containing entry doors (Site Photo 14).

Site Photo 14. MOUT facility interior

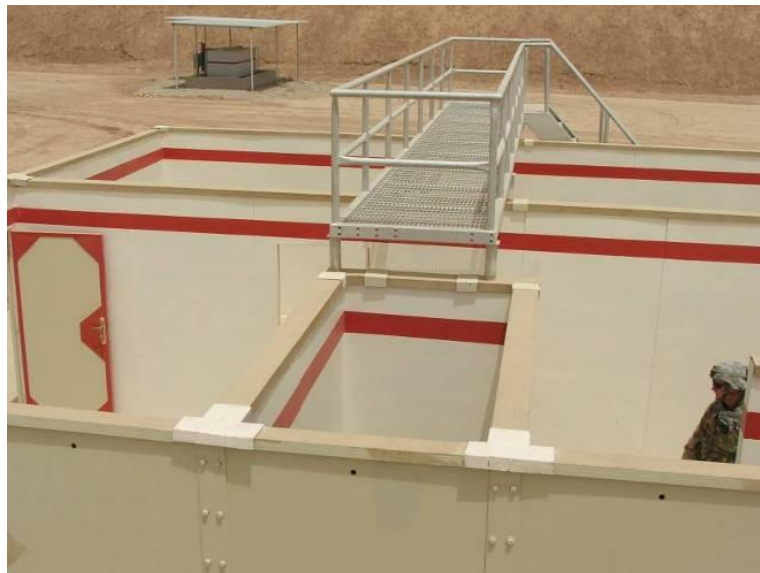
Observation platforms were constructed above the training structures (Site Photo 15). The platforms consisted of galvanized steel framing, open grate steel deck, and handrails. The steel framing for the platform was supported on the training structure's wall panels.

Site Photo 15. Observation platform

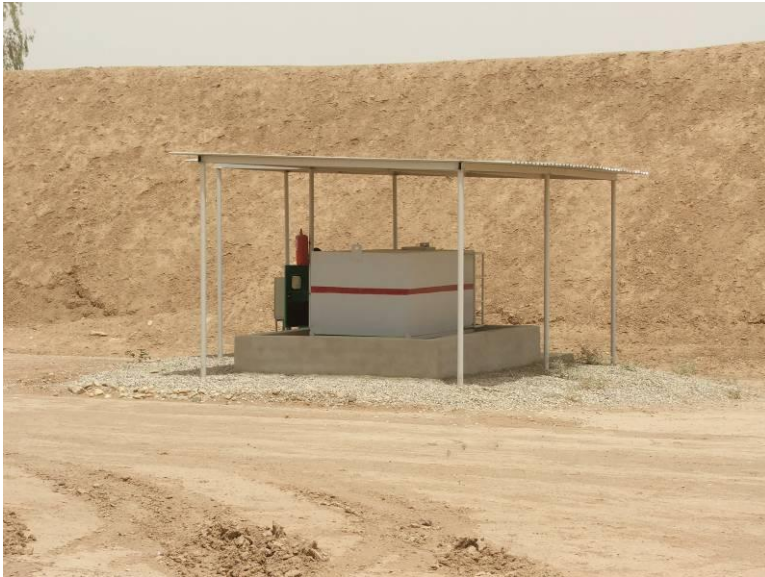
Site Photo 16. Sunshade with generator and fuel tank

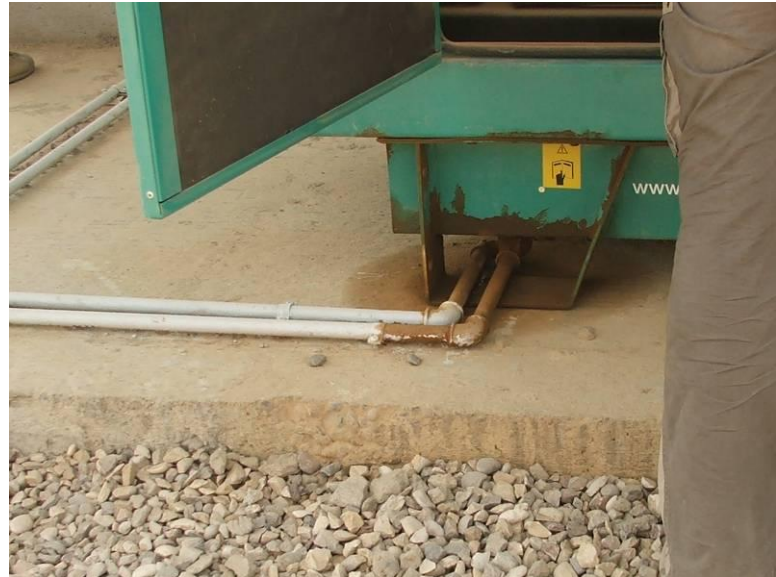
The generator was connected to the fuel tank with galvanized steel piping. SIGIR noted that there was evidence of a fuel leak at one of the joints in the fuel line (Site Photo 17). The GRN Mosul Area Office representative stated that the leak was previously discovered and repaired and that the fuel seepage noted during the site assessment was from an earlier leak. During the site assessment, the GRN Mosul Area Office representative attempted to start the generator. The generator started, but did not continuously function. Due to the limited time available, SIGIR was unable to determine the cause of the generator fault. However, the generator not functioning could be due to a lack of system load and not a defect in the power generation system.

Site Photo 17. Fuel leak at joint

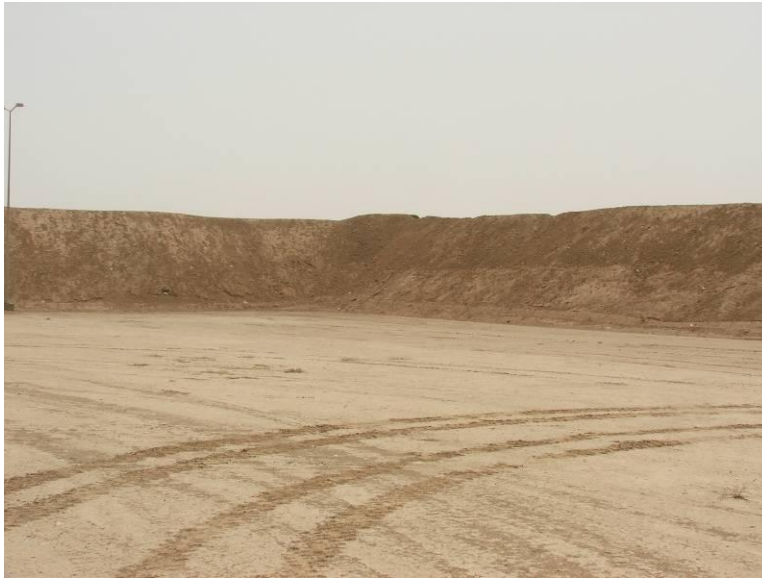
The MOUT facility perimeter earthen berm was similar in construction to the berm surrounding the multi-purpose small arms range (Site Photo 18). The berm was constructed with a uniform cross-section and uniform height. The berms surrounding the range appeared to be constructed with native fill materials, which consisted almost completely of fines with low plasticity and little or no cohesion and appeared to be highly erosive. Also, the contractor provided no method of stabilization for the embankment.

Site Photo 18. Perimeter berm around MOUT facility

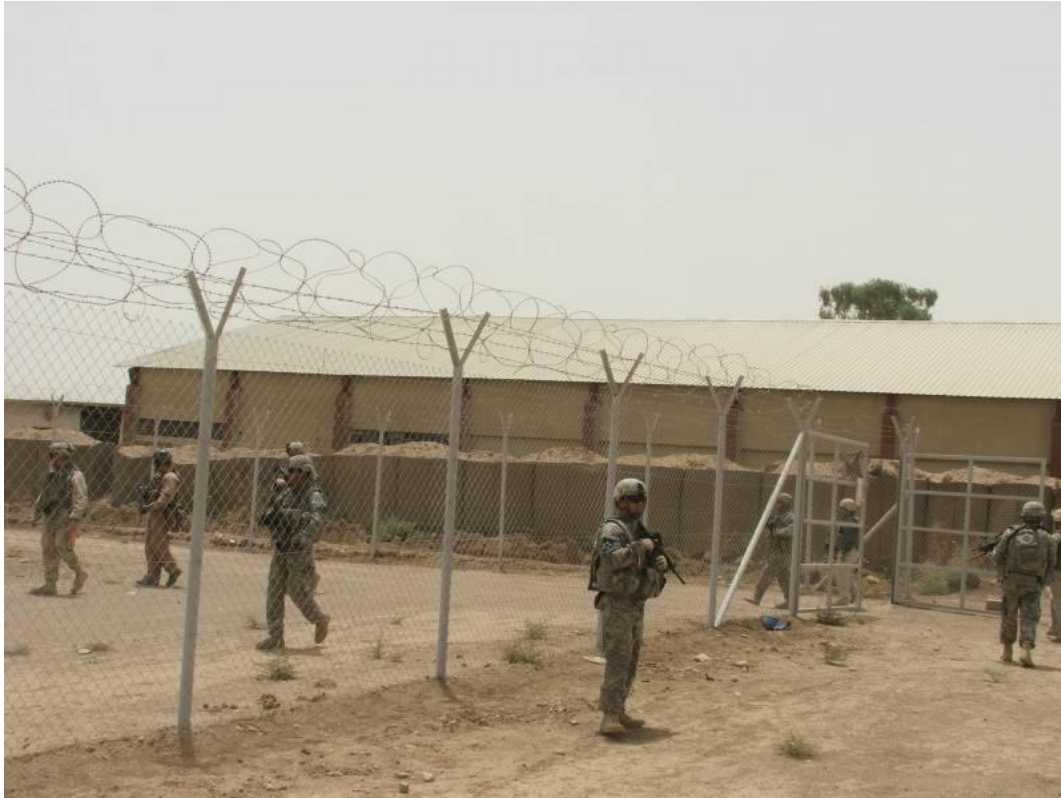
Site Photo 19. Perimeter fence for combat assault course

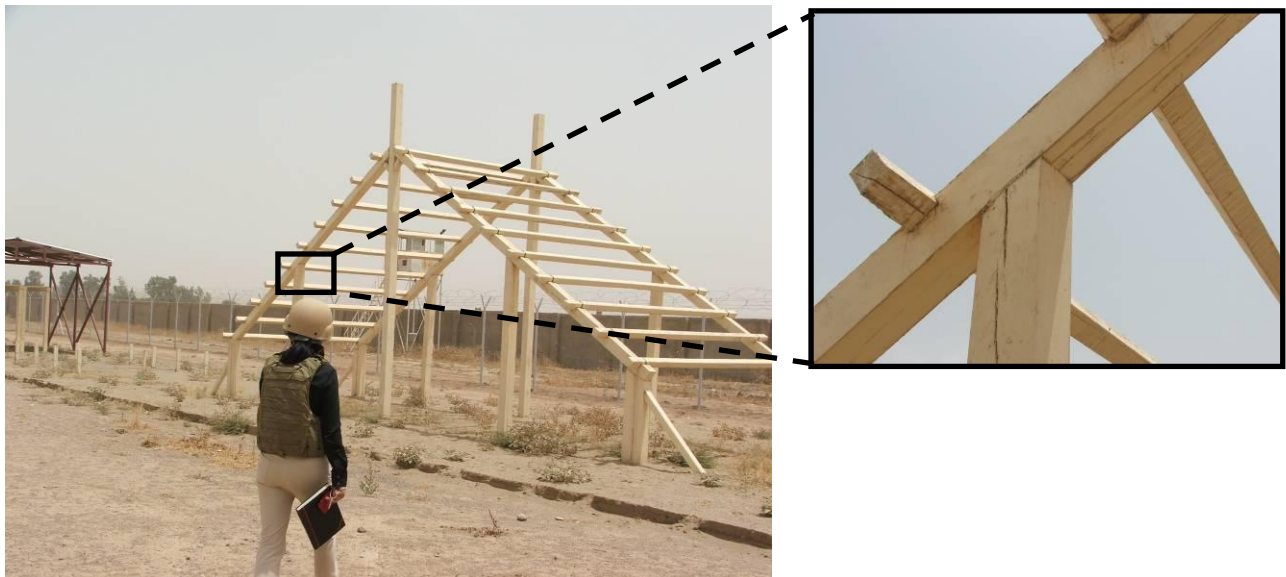
The SOW required that areas surrounding and underneath the obstacles should consist of a deep bed made of sand, sawdust or crushed/ground rubber. SIGIR observed that the obstacles were constructed over native material similar to the ground cover on other areas of the project. It does not appear that provisions were made to place the required ground cover beneath the obstacles.

Site Photo 20. Obstacles for combat assault course

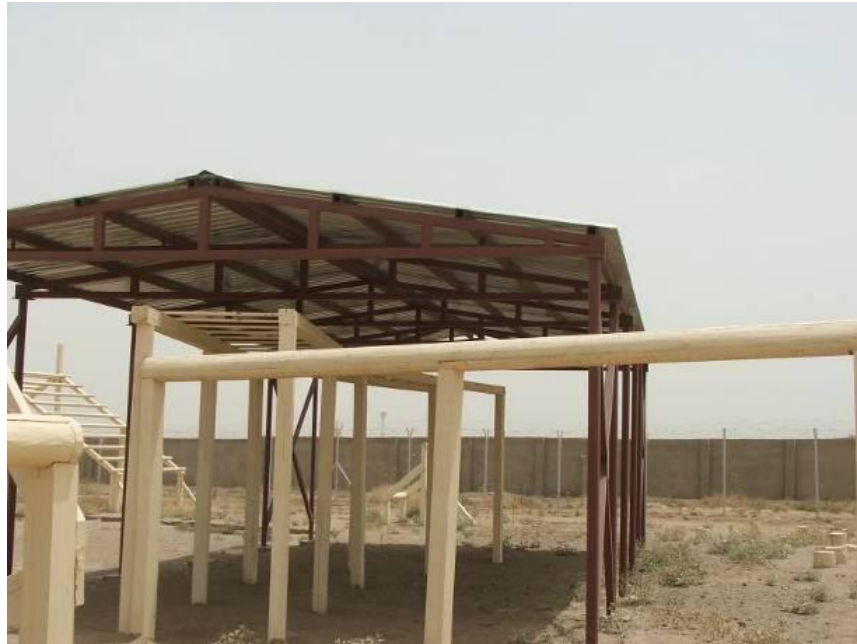
A sunshade was constructed over one of the obstacles. The sunshade consisted of corrugated metal over steel roof trusses supported on steel columns (Site Photo 21). At the time of the site assessment, the sunshade construction was complete, so the configuration of the foundation could not be determined. However, SIGIR did not observe any apparent movement or settlement of the footing. The steel framing appeared adequately constructed, and there were no failures or displacement of the members evident at the time of the site assessment. Cross bracing was provided at end bays to provide lateral stability for the structure.

Site Photo 21. Sunshade over obstacles for combat assault course

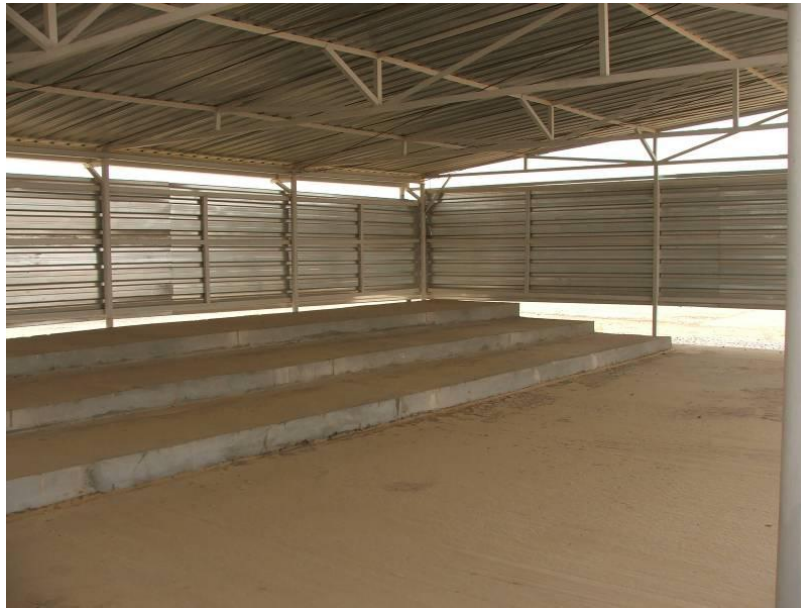
The SOW required translucent material for the cladding and provided specific details for windows inserted in the walls. SIGIR observed that the exterior cladding of the buildings was not consistent with the SOW, and the outdoor training facilities did not contain windows or translucent material for cladding.

Site Photo 22. Outdoor training facility (interior)
